Retrofitting a Telematics Control Unit (TCU) with Bluetooth® Technology

E90, E91, E92 (3 Series) with SA640 (Phone prep)

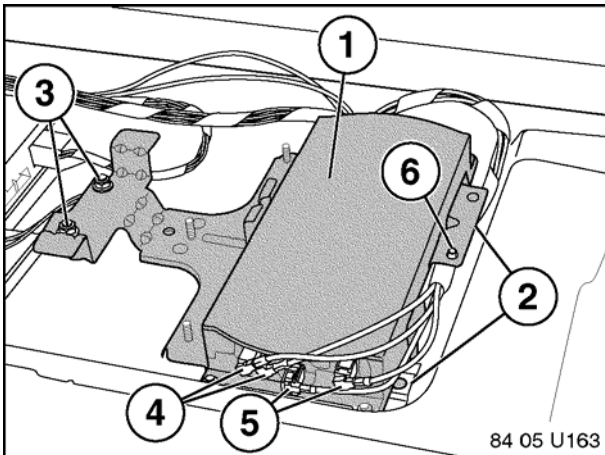
5. Connect the TCU connectors (4 and 5) to the TCU (1).
6. Slide the bracket assembly into the tabs in the trunk floor (2) as shown, and secure with two Hex nuts (3).
7. Secure the harness clip into the bracket (6).

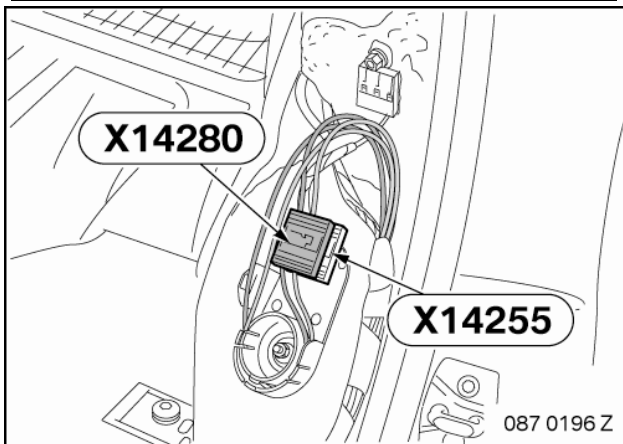
8. Fold down the driver's side rear seat backrest and remove the left backrest part to access the MOST junction blocks **X14280** and **X14255**.

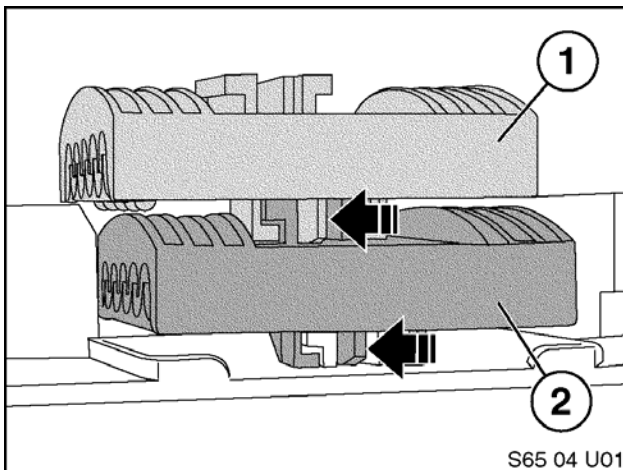
9. Separate the upper black junction block (1) from the lower black junction block (2) by pushing the locking tab (black arrow) to the left and sliding the upper block rearward.
10. Separate the lower junction block (2) from the plastic mounting bracket by pushing the locking tab (black arrow) to the left and sliding the block rearward.

Fiber optic cables not shown in illustration S65 04 U01.

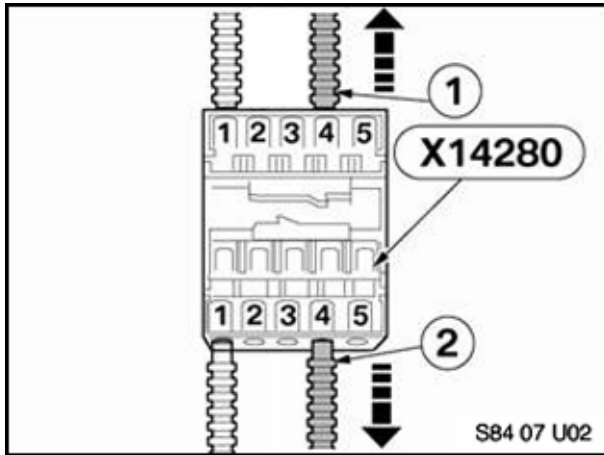
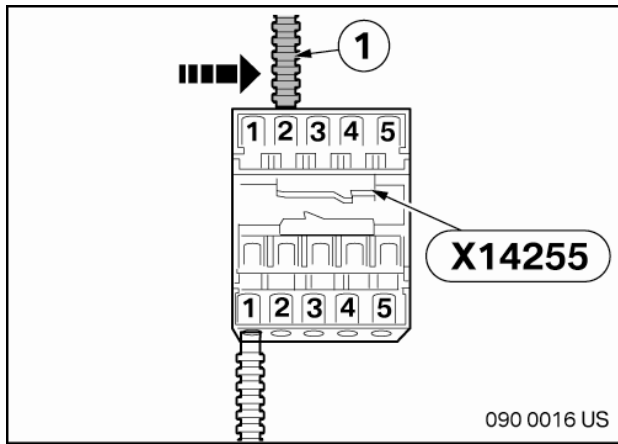
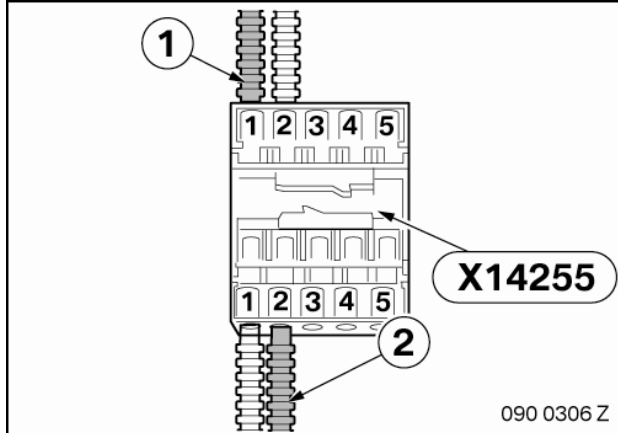
11. Unlock the cover caps from the MOST-bus junction blocks, with the aid of a small flathead screwdriver.
12. Remove the TCU fiber optic cables (1 and 2) from the upper black junction block **X14280**, with the aid of a small flathead screwdriver.
13. Remove the fiber optic cable (1) from **Position 1** on the lower black junction block **X14255**, and re-connect it to **Position 2**.

Note: The number of fiber cables connected to MOST junction block **X14255** may differ than shown, depending on vehicle options.

Note: It may be necessary to remove and re-connect multiple fiber cables into the next slot positions from Step 14 if Position 2 is already occupied.

14. Connect the TCU fiber optic cable (1) removed from junction block **X14280** in Step 13 into the empty slot **Position 1** of junction block **X14255**.
15. Connect the TCU fiber optic cable (2) removed from junction block **X14280** in Step 13 into the empty slot **Position 2 (or the next available slot, depending on vehicle options)** of junction block **X14255**.

16. Lock the cover caps onto the upper and lower black junction blocks, and resecure both junction blocks to the plastic bracket.

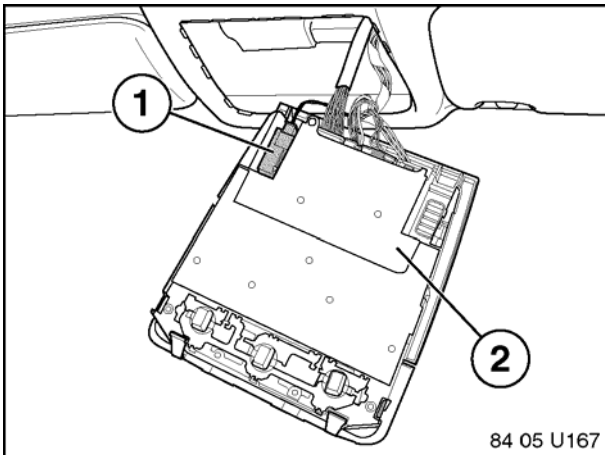
27. Reconnect the removed connectors and install the microphone (1) into the SOS-equipped light switch console (2).
